The Yokohama 29.5R25 RT41 L4 and 29.5R25 RB31 L3 are Off-the-Road tires that have been specifically designed for replacement tire applications on various front end loaders. There are several manufacturers who produce equipment that use this particular size, e.g.: Caterpillar 980 (most models), Komatsu WA500, etc.

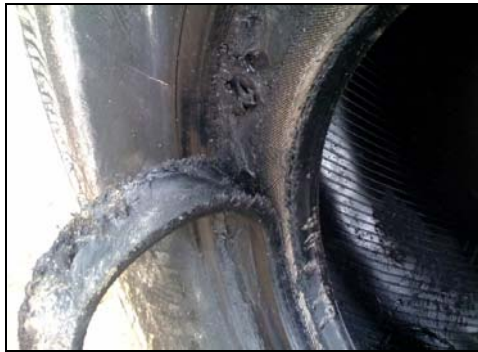
Some of these manufacturers provide these particular loaders with three-piece wheels from the factory as opposed to a five-piece configuration. Yokohama has experienced a sporadic condition where there is significant slipping/indexing of the rim and tire assembly on three piece wheels but not on the five piece configuration. This slipping/indexing creates a condition where the rubber in the bead area is damaged down to the bead bundle/core and can cause significant air loss over time.

*Bead damage due to
bead and rim slip on 3
piece wheel assemblies*

First, we recommend that when mounting a brand new Yokohama 29.5R25 RT41 or 29.5R25 RB31 onto the wheel, the air pressure is set to 120 psi, or max pressure the wheel is rated for, and allowed to sit for 24 hours to allow the tire to seat properly onto the wheel before usage. The air pressure should then be bled down to the proper recommended air pressure for the operating conditions.

First, Yokohama highly recommends replacing the current three piece wheel assembly, with a proper CNC machined assembly, which has been sand blasted for a proper finish. This will provide the proper mating surface in order for the tire to seat properly and prevent any wheel and tire slippage or indexing e.g.: Rimex Part No. 825-025-0164-01. Please consult your wheel manufacturer for more information.

Second, Yokohama has not experienced this bead rim slip condition on five piece wheels configurations and the user has the option to upgrade to a five piece wheels assembly. Please consult your wheel manufacturer for more information.

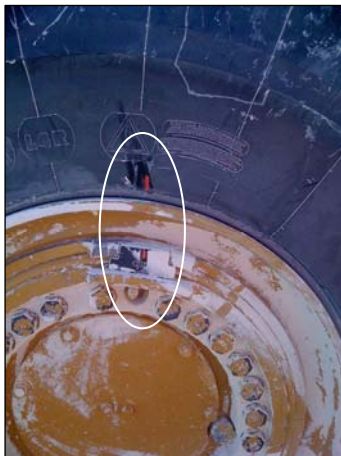
In order to check if there is any slipping or indexing of the rim and tire assembly, the following procedure may be used. By marking both the rim and tire with one highly visible line as seen in the following picture, the rim and tire assembly are now registered. Any significant deviation between the two registration marks, creating a straight line, indicates that there is some slippage/indexing between the rim and tire.

*Red chalk mark which
registers the rim and
tire assembly*

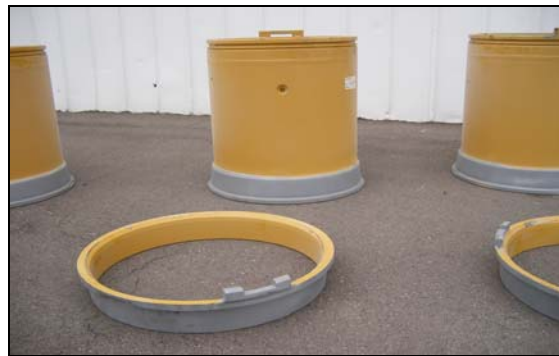
CNC Machined BSB and Back Section
